LAKE HURON

2020 ANNUAL REPORT

LAKEWIDE ACTION AND MANAGEMENT PLAN

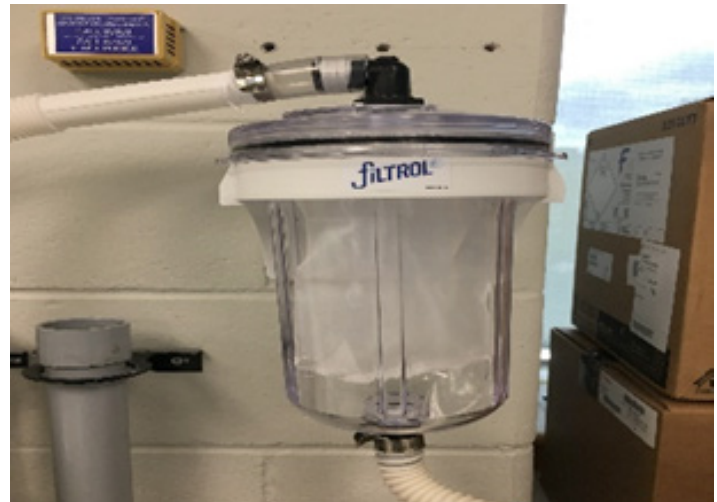
Innovative filter technology to reduce CMCs and microfibers in the Lake Huron Basin. Source: Sam Athey.

One such project, funded by ECCC, studied the benefits of adding filters to household washers and dryers to divert chemicals (such as PCBs and PFAS) and microfibers (tiny strands of plastic pollution) that come off your clothes during laundering. These filters can prevent these pollutants from entering the Great Lakes.

wastewater treatment plants capture some contaminants and the bulk of microfibers, final effluent from the plant can still discharge these substances directly into the lake. Preliminary results from this project suggest that the washer and dryer filters were effective at reducing some of these unwanted substances from entering Lake Huron. Find out what you can do to reduce [chemicals](#) and [plastics](#) from entering the Great Lakes.

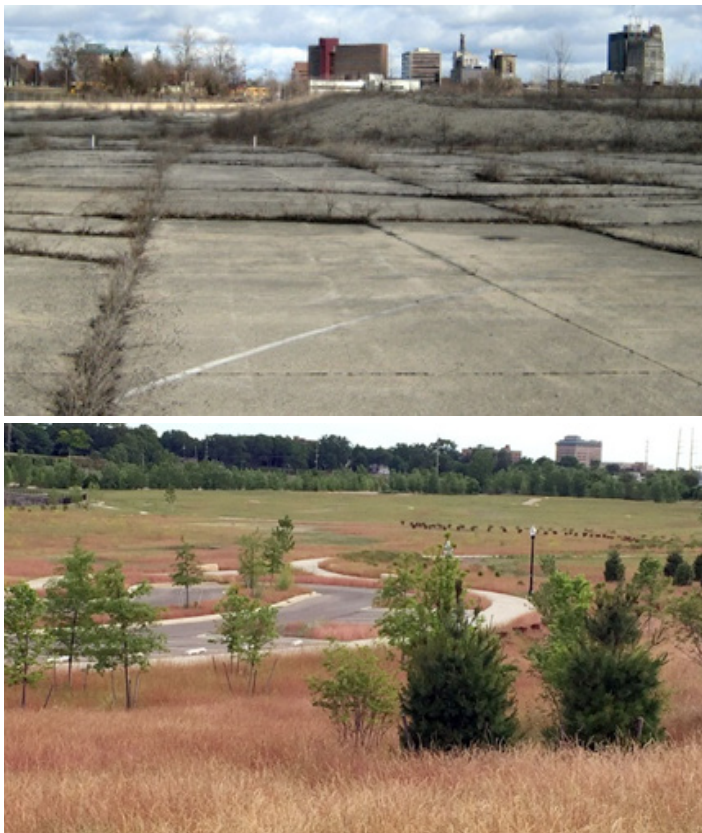
Before and after photos of “Chevy Commons”. Source: Genesee County Land Bank Authority.

In the first stage, about 18 acres (7 hectares) were planted with selected fast-growing trees, such as willow and poplar, to create a green buffer that captures contaminants in soil and water, a process known as [phytoremediation](#). Another 20 acres (8 hectares) of the site included a variety of native trees, shrubs, prairie plants and no-mow grass for a low-maintenance cap that provides wildlife habitat and natural stormwater storage.

These efforts reduced runoff into the Flint River, improved soil and groundwater quality, and slowed the movement of contaminated groundwater.

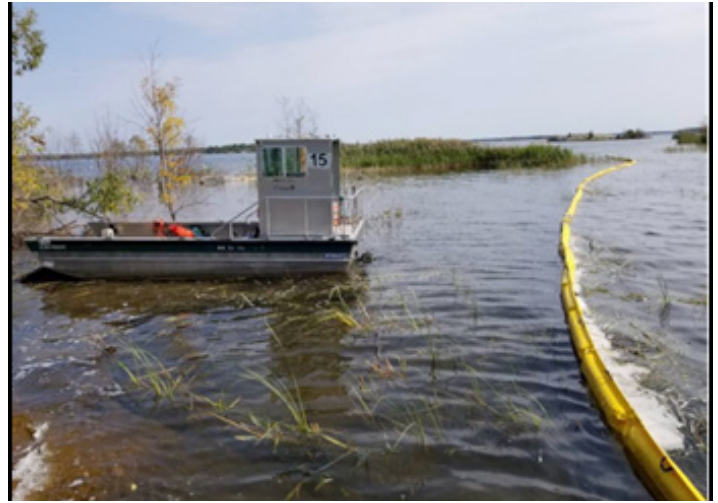
Photo of a barge used to transport the cut biomass and the floating boom installed to prevent the spread of Phragmites during removal at Georgian Bay Islands National Park. Source: Parks Canada.

Georgian Bay Islands National Park's "Impede the Reed" project made significant headway in managing several priority invasive Phragmites patches around Beausoleil Island, removing a total of 1.3 hectares (3 acres) using mechanical and hand pulling methods.

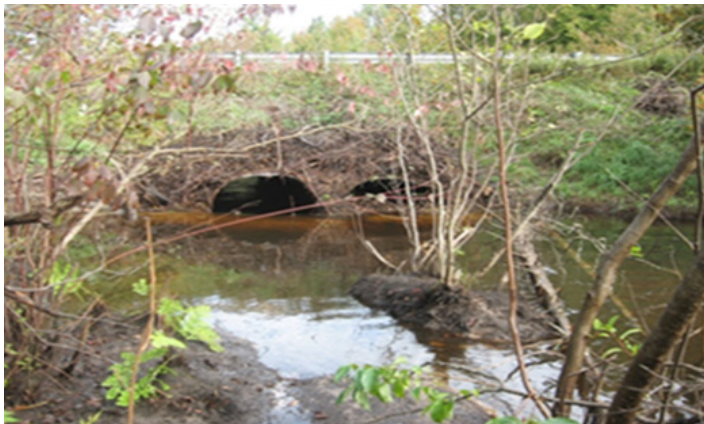
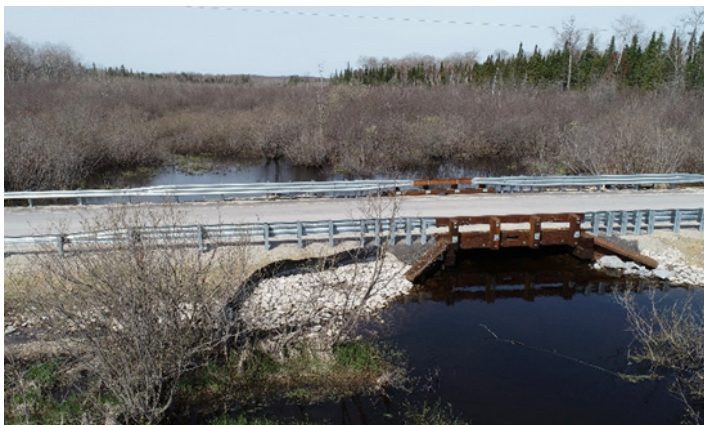
Before and after road-crossing improvements, Carp River (Gill Rd). Source: LTBB.

Twin undersized and failing culverts were removed from Van Creek at Reed Road and the Carp Lake River at Gill Road. Timber bridges were constructed in place of these culverts to restore fish passage, decrease roadway flooding, reduce erosion and improve aquatic connectivity. The Van Creek project added over five miles of upstream habitat in the Lake Huron Basin. Future plans include replacing two more culverts in downstream sections.

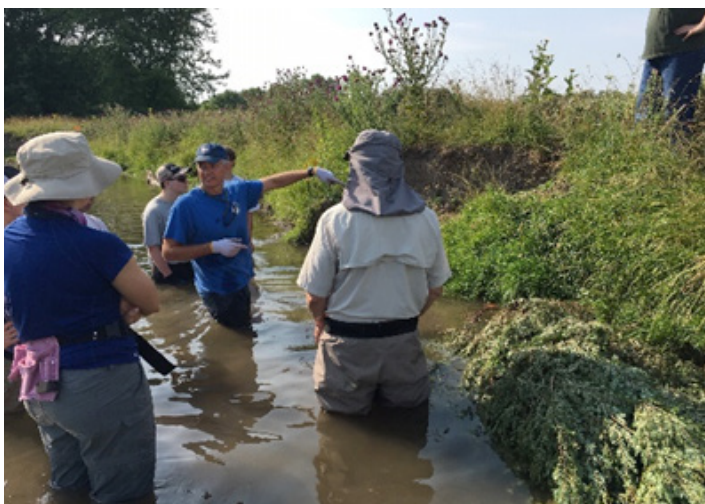
Photo of Bank stabilization using discarded Christmas trees & soil anchors. Source: NVCA.

In 2020, a 400 m (1312 ft) long reach of the Nottawasaga River was restored through 355 m (1164 ft) of bank stabilization, 2,970 m² (5,379 ft²) of floodplain creation and the planting of 1,325 native trees and shrubs. The work was coordinated by the Nottawasaga Valley Conservation Authority and Nottawasaga Futures, with help from the Ontario Trillium Foundation, Fisheries and Oceans Canada, Patagonia–Tides Foundation and HJ McDonald Foundation.
